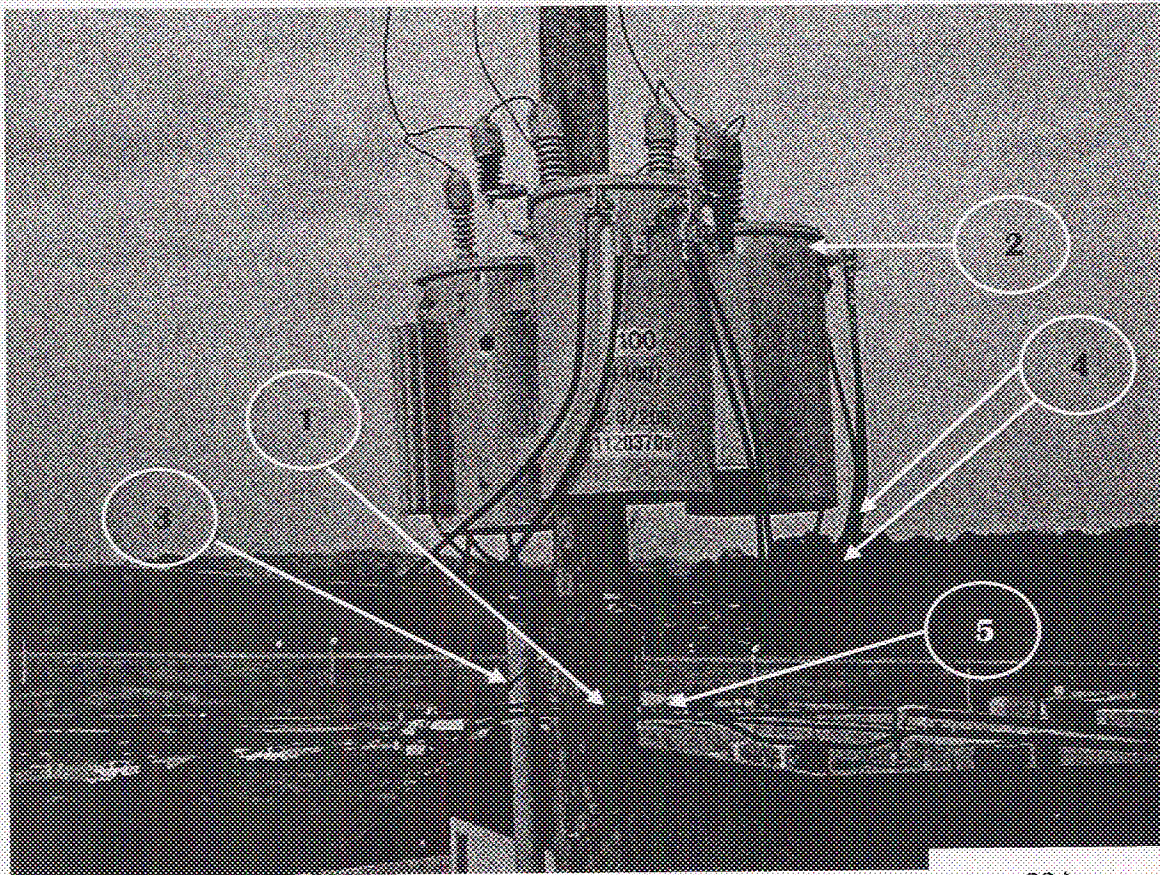
-- 22A --

One of Entergy's central contentions is that electric facilities always are on the poles first and that cable facilities always come later. This is so it can argue that whenever there are clearance violations, they have been created by cable. This photo shows that this is not true. The three-phase transformer bank depicted in this photo were installed within the last several months to provide electric service to a new McDonalds restaurant. The poles and the cable television attachments (Arrow #1) were installed before the offending riser conduits and transformers. Cox was attached in compliance. The new transformer cans (Arrow #2) the grey "riser" conduit (Arrow #3) and the electric wires (Arrow #4), were installed after cable. There are no more than a few inches of separation between the hot electric wires coming out of the riser (Arrow #3) and Cox's facilities (Arrow #1). The NESC mandates that there should be 40 inches between the riser cable and the Cox attachment. I believe that this pole was set by EAI to provide adequate vertical clearance above the new driveway at the McDonalds. These photos were taken at the direction of Jeff Gould of Cox.

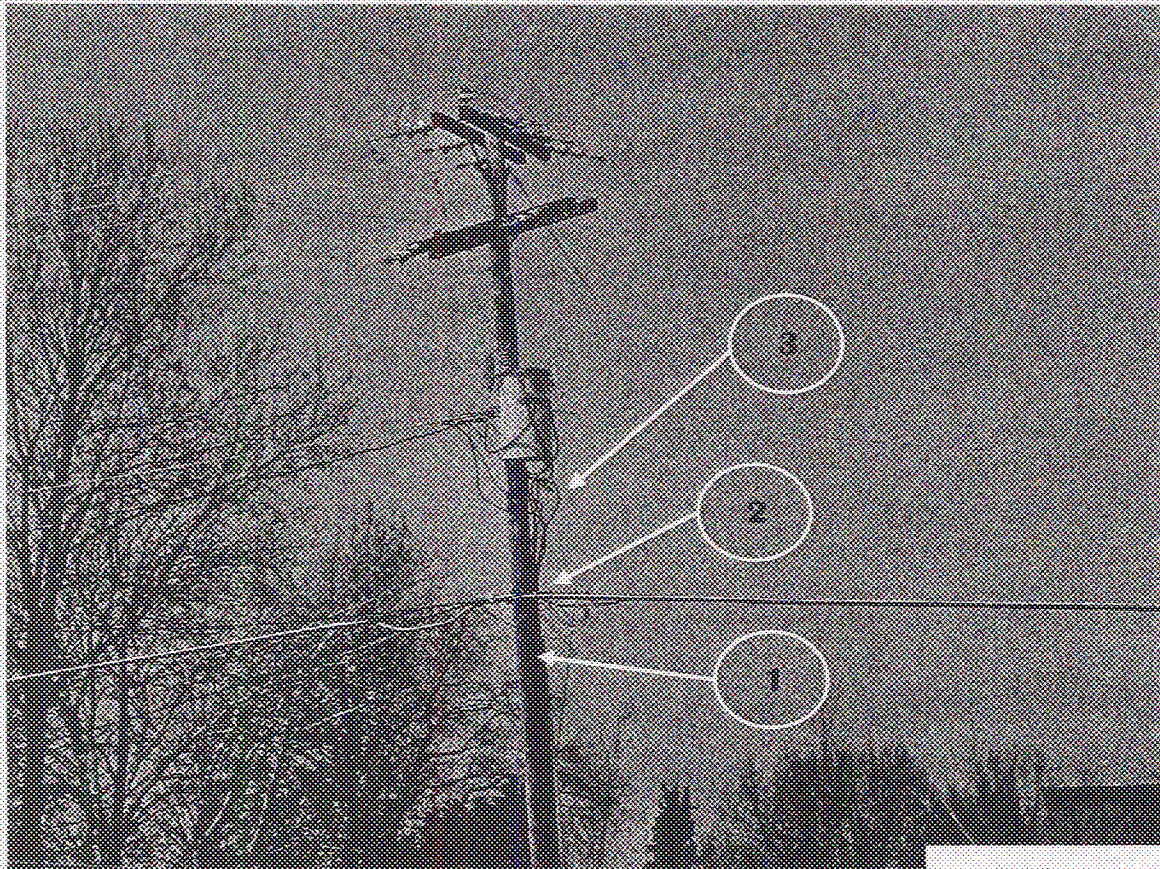
- 23A -

This photo, which I took, presents another good example. It shows an EAI secondary underground service riser pipe (Arrow #1) stopping more than 12 inches *below* the cable television facilities (Arrow #2) located on this pole. The NESR requires this electric conduit to be 40 inches above cable. You can see that there are two underground service drops running from the transformer and the loops coming out of the transformer are very sloppy (Arrow #3). Putting the proper length of conduit and placing the loops correctly could have been done easily. Underground service risers such as these are usually added long after the cable television facilities have been installed. Other examples of poorly installed electric facilities that went in long after cable appear in the next photo. Location: Jacksonville, AR Alley between N. Bailey Blvd & N. James St.

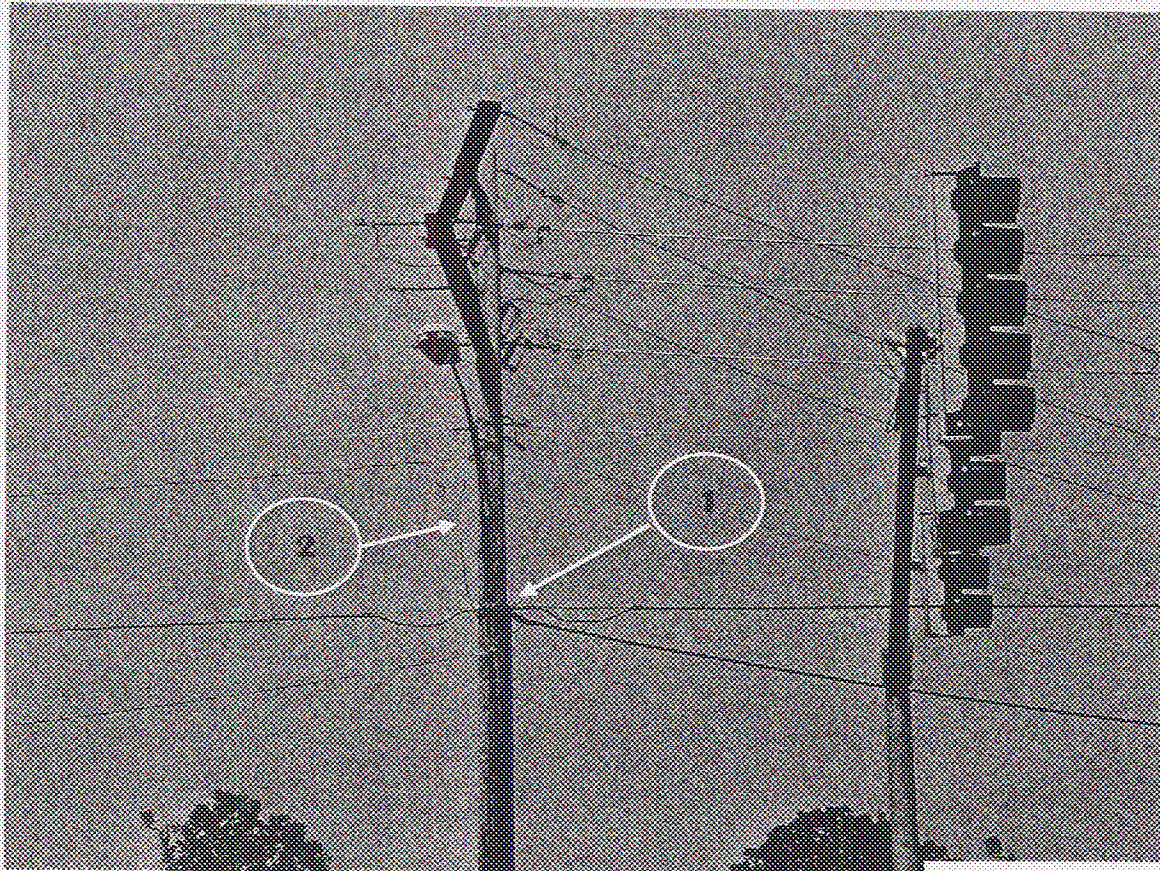
- 24A -

This photo, which I took, shows an EAI service to a new traffic signal. Electric power to supply the traffic signal is wired by the governmental agency or contractor. Metal conduit with two wires for 120 volt power is extended up this pole (Arrow #1). In this case, EAI should not have made this connection because of this NESC violation, and required the conduit owner to extend the conduit to 40 inches above cable television. You can see several exposed wires hanging beside the pole next to EAI's secondary on the left of the pole (Arrow #2). This is a blatant violation of the NESC's 40 inch rule. Connections to a new service (in this case traffic) must be 40 inches above cable. EAI should remedy this by placing a "u-guard" (which is essentially one-half a plastic conduit over the traffic signal leads, or require the owner of the traffic signal to extend the weather head up to 40 inches or more above cable. Location: Jacksonville, AR W Main St at N. Bailey Blvd.

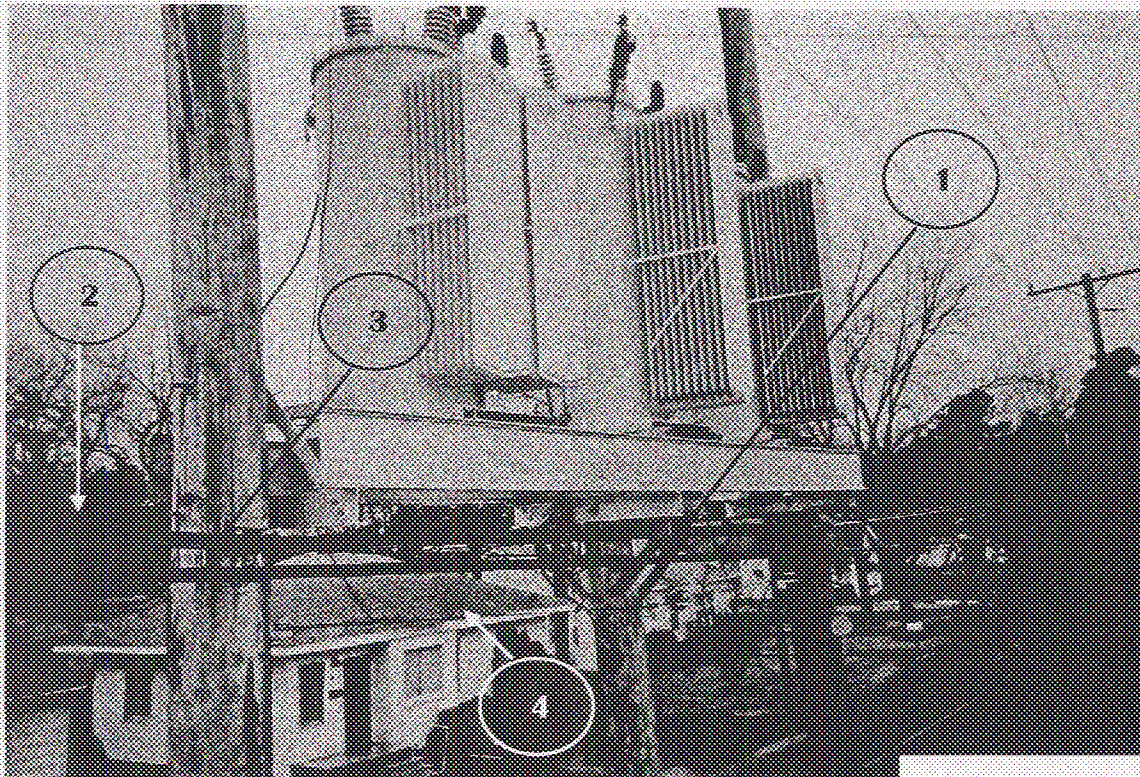
- 26A -

This photo, taken at the direction Jeff Gould of Cox Communications, shows a multi-pole platform-mounted voltage regulator that Entergy has installed *after* the installation of communications facilities. Note on the center pole the steel bracket (Arrow #1) that has completely boxed in the two sets of communications lines on the poles. The top line is the cable attachment (Arrow #2). EAI set new poles, pulled Cox's cable down and physically forced it beneath a bolt through one pole (Arrow #3). EAI built its neutral wire below the telephone cable (Arrow #4). Neither cable tv nor telephone is attached to either pole or bonded to the pole grounds. This creates a very dangerous situation. In installing these facilities Entergy has violated NESC rules, cable tv, telephone and EAI standards. This photo shows that EAI has a lack of understanding of the NESC, lack of training, no inspection of new construction and a complete disregard for users of the communications space. Electric companies, like communications companies from time to time must add new facilities to their networks. But they must do so in a way that respects the rights of others to occupy the poles, including providing adequate notice of the work that they wish to perform on the poles.

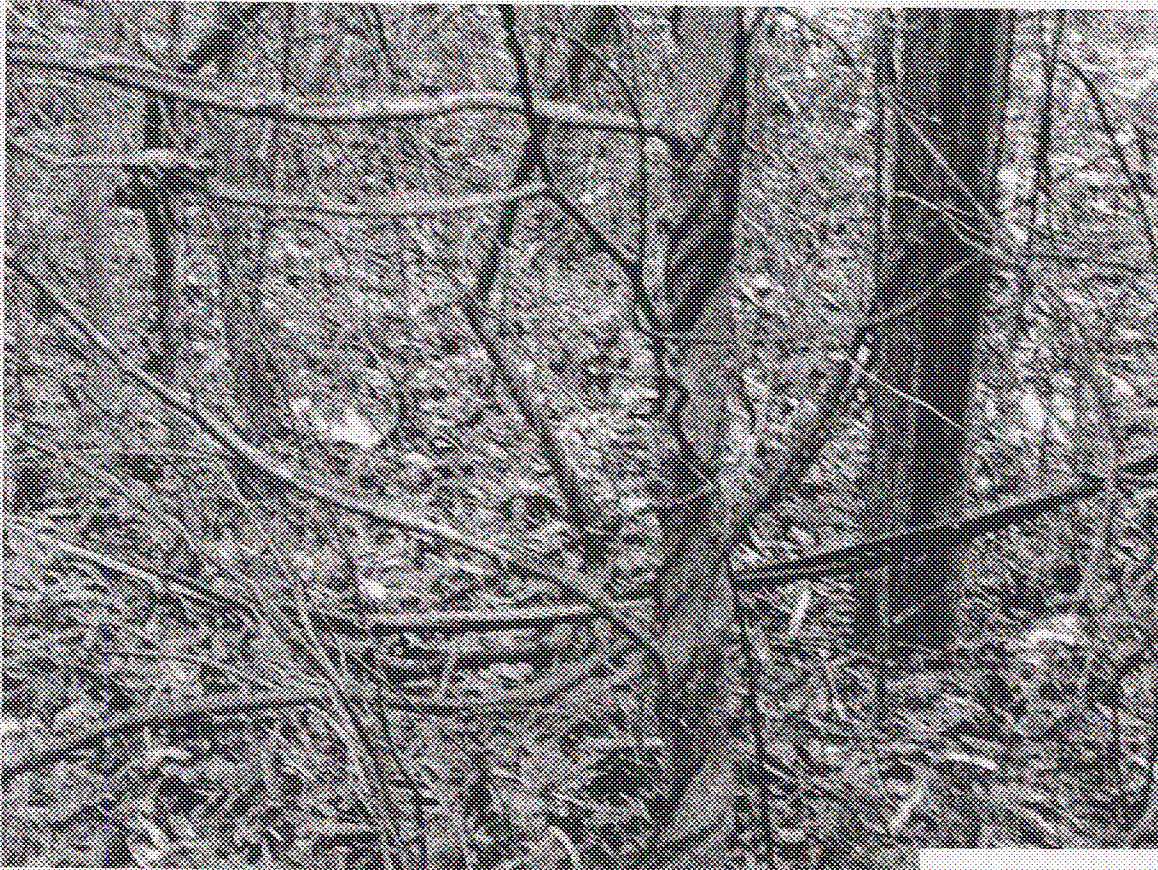
- 38A -

This photograph, which was taken at the direction of Comcast's Marc Billingsley, shows a hot EAI electric service lying on the ground of some woods near a residential area in Little Rock. This hazard was initially reported to EAI by USS during its "safety audit." Comcast discovered it during a follow up engineering trip to the pole, identified by USS. Entergy still had not reattached it to the pole as of June 7, 2005. A hot wire on the ground is a serious hazard to the public. This illustrates a major clear disconnect between EAI's claimed emphasis on safety and its trouble response department.

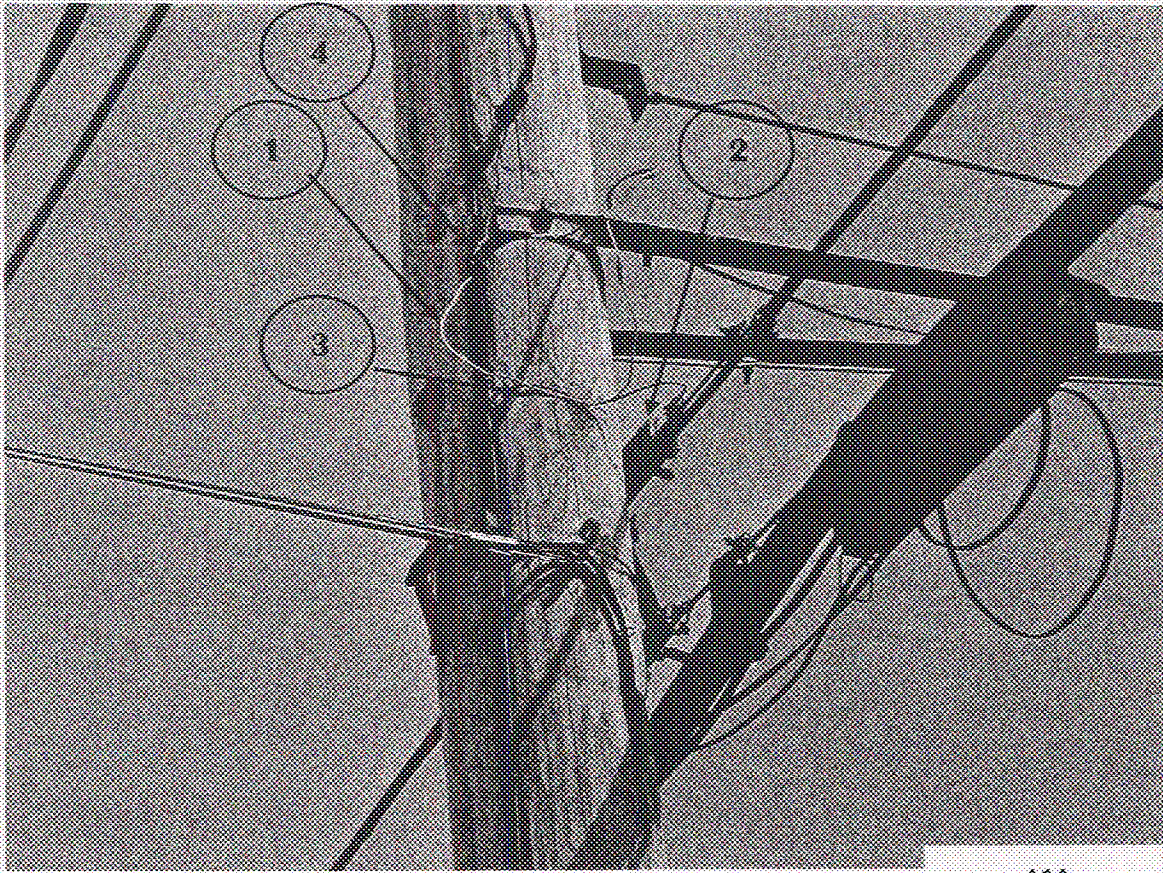
- 41A -

This photo, which I took, shows a street light which EAI could readily have installed in compliance with the NESC but the white lead from the light (Arrow #1) runs down the pole until it almost touches the cable tv attachment (Arrow #2) and does touch the cable bond wire (Arrow #3). Then this white street light lead goes back up and connects to the EAI pole ground wire (Arrow #4). EAI has created three violations here. First, street light leads must be 12" above CATV. Second, the white neutral lead must connect to a neutral conductor (wire) not a pole ground wire. Third, the street light bracket must be grounded, or, the bracket must be 20 inches from cable. EAI's contractor, USS, which inspected this pole has seldom noted a street light grounding violation and never noted an incorrectly connected neutral. These numerous violations of the basic provisions of the NESC create real hazards to communications workers and electric workers alike and are the responsibility of the electric company to correct. Jacksonville, AR. N. First St.

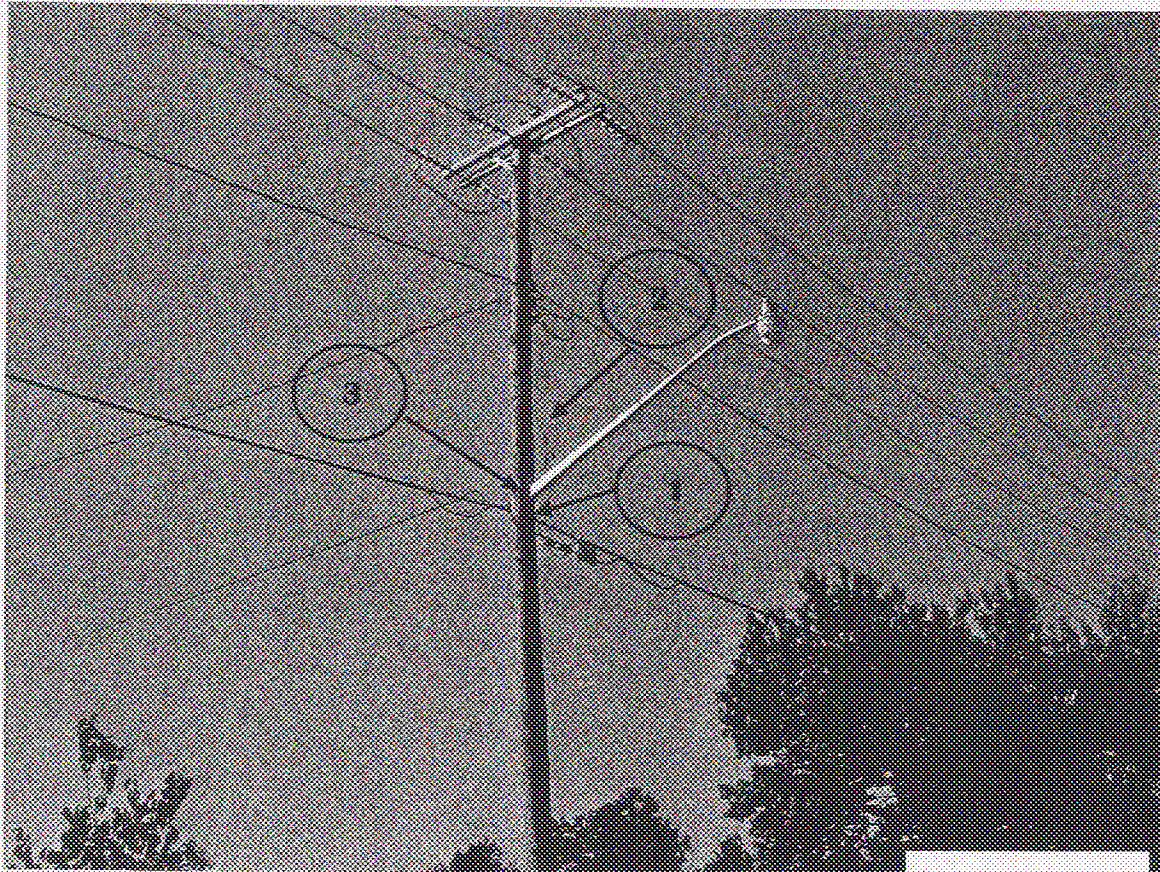
- 42A -

This photo, which I took, shows a street light placed much too close to cable (Arrow #1). One hot wire lead (120 v.) hangs down alongside the pole (Arrow #2). The neutral wire for the light is connected to the pole ground at the same level as the cable television attachment. The bracket is not grounded (Arrow #3). There are four significant EAI violations at this location: (1) the street light leads are less than 12 inches to cable; (2) the bracket is grounded and is less than 20 inches to cable; (3) the neutral is connected to pole ground; (4) the long, hot wire is not secured to the pole. Location: Little Rock Mablevale Pike.
